This SB revises SB-912-064UL/SB-914-045UL Initial issue dated 10 October 2013

### Periodic checking of the crankshaft journal (power take off side) for ROTAX® Engine Type 912 and 914 (Series)

ATA System: 72-20-00 Engine block

# Periodic checking of the crankshaft journal (power take off side) for ROTAX® Engine Type 912 and 914 (Series)

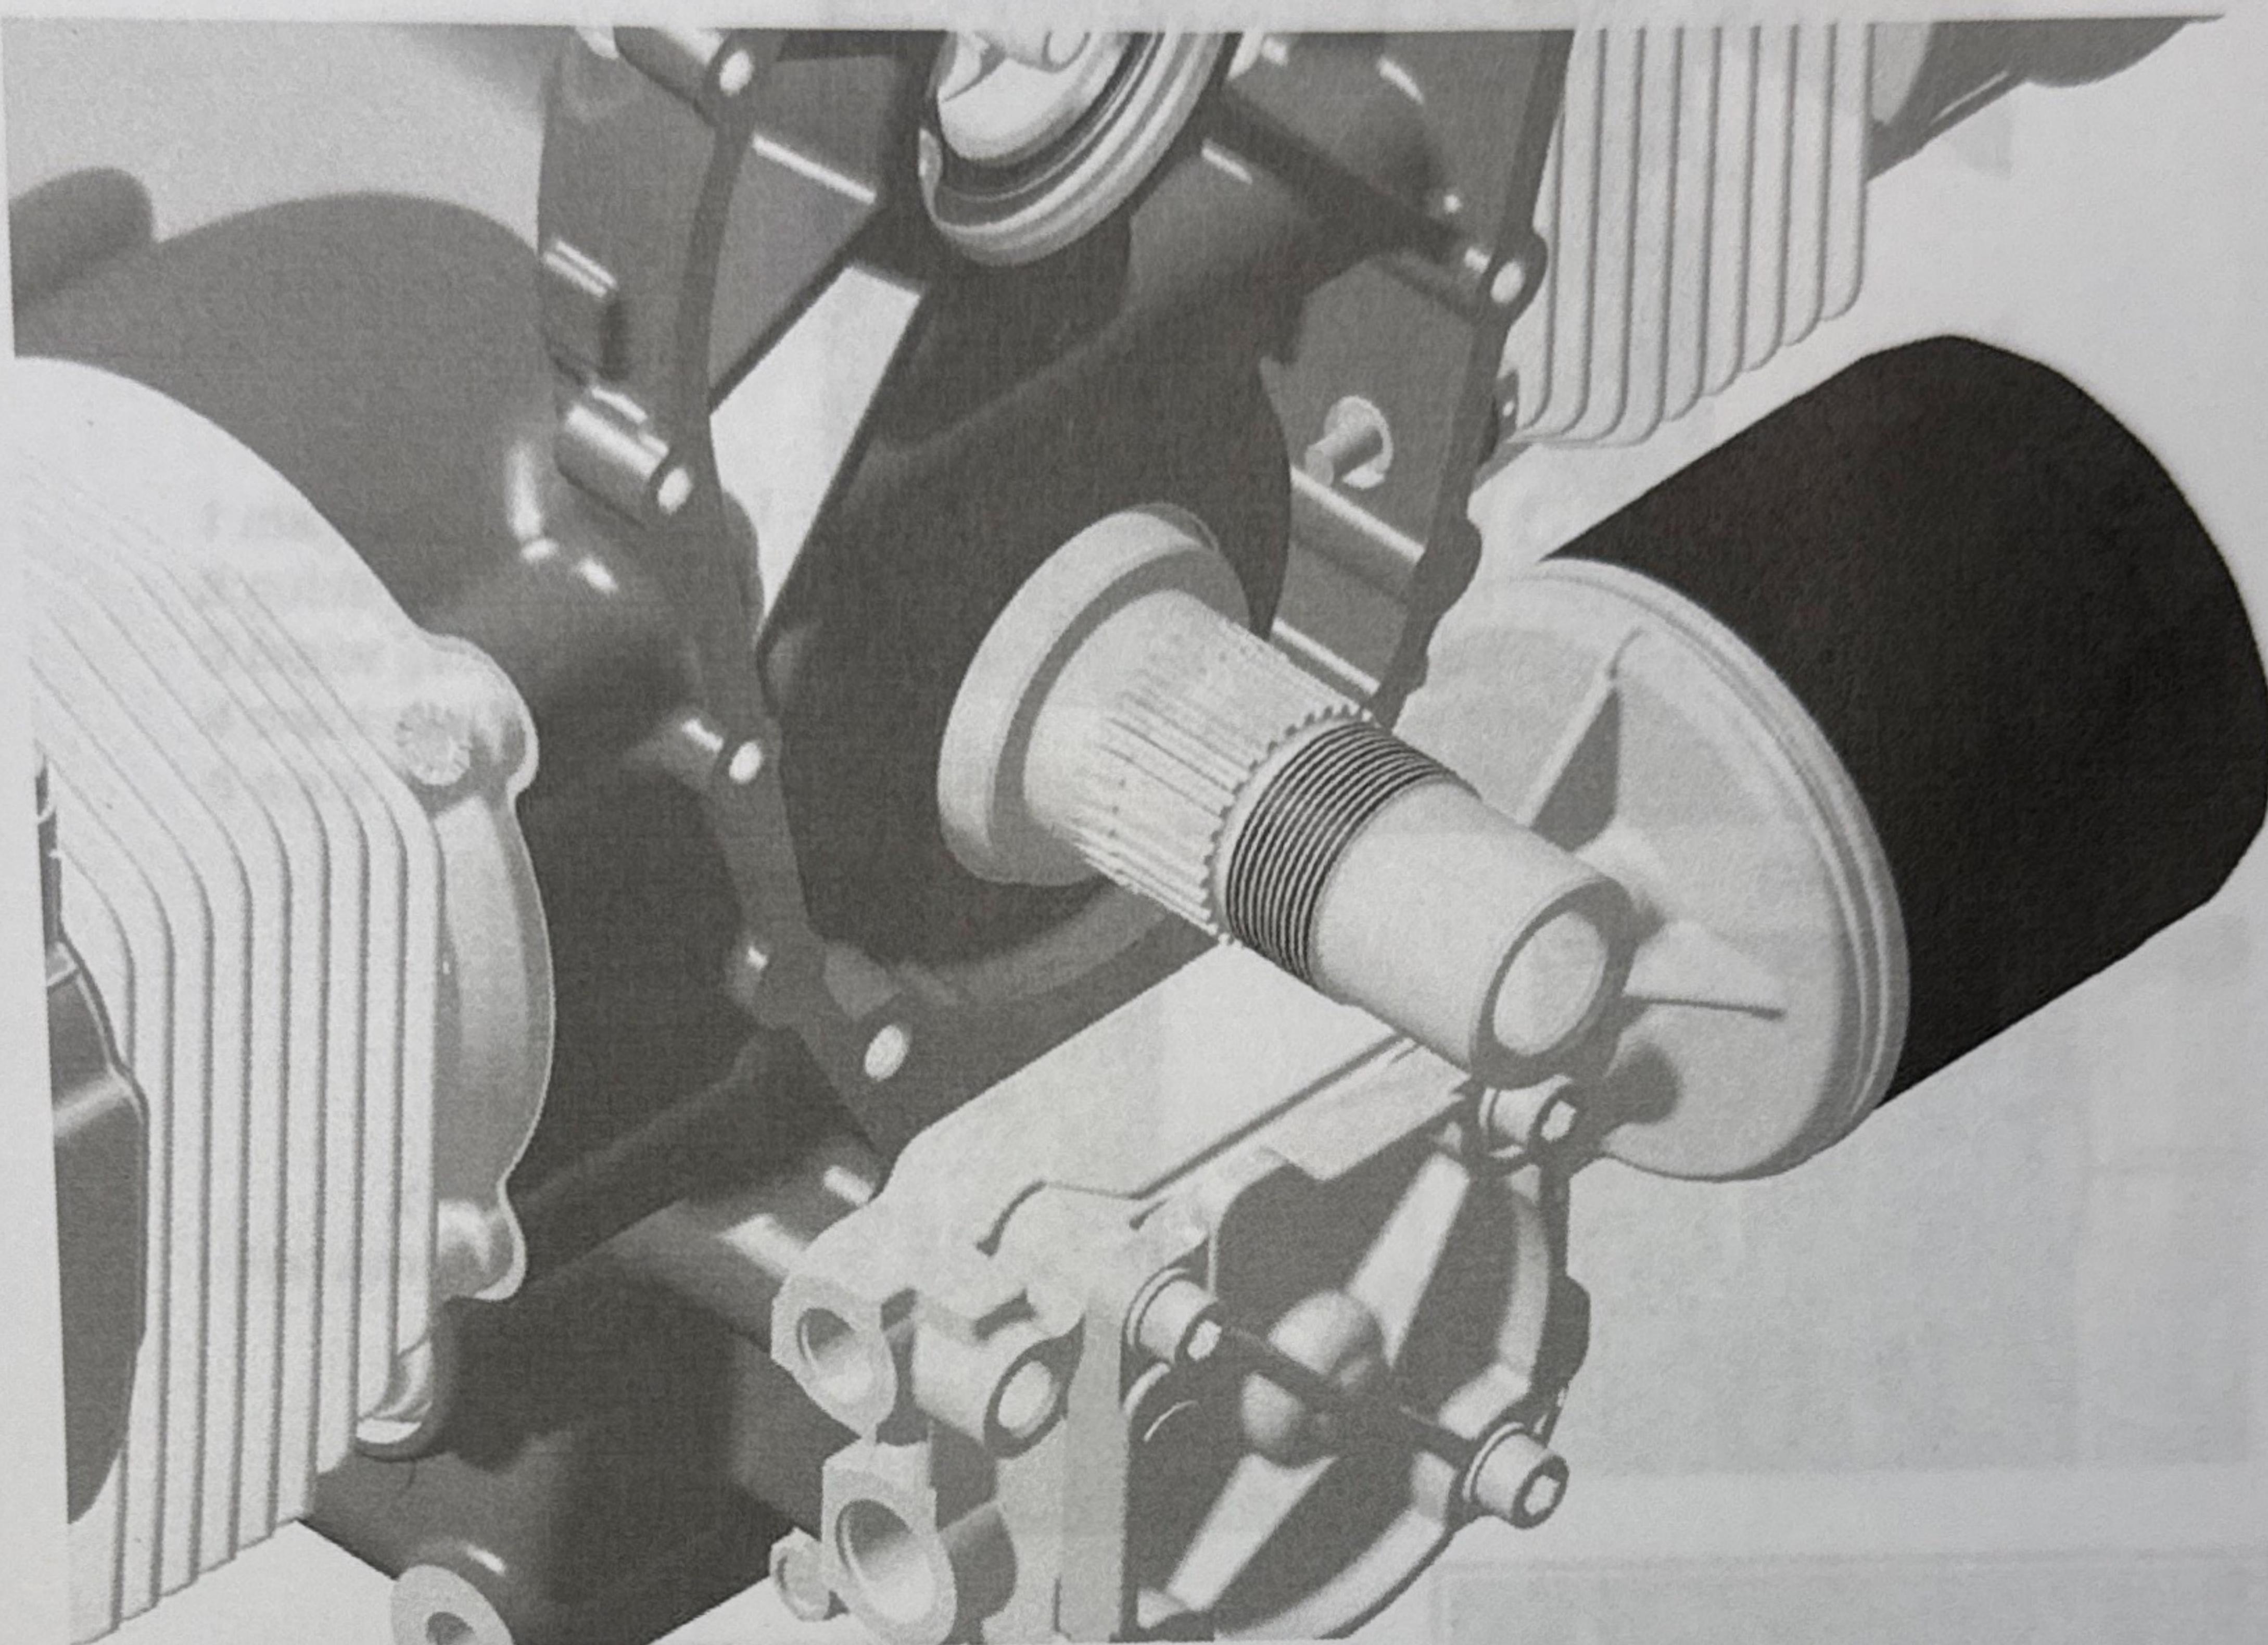
**Fig. 1**  
**Crankshaft journal**

Due to a deviation in the manufacturing process some crankshafts may develop a crack on the power take off side. These cracks can cause breakage of the crankshaft in the support bearing during operation. In this case the function of the support bearings (consisting of 3 main bearings and 2 support bearings) is compromised. The operating reliability, however, is given until the next maintenance.

Step	Procedure
1	Remove the magnetic plug in accordance with the relevant Maintenance Manual (Line).
2	Install guide pin (2) of the check gauge CS-PTO into the magnetic plug thread until stop. Adjust the guide pin with the flat spot (X) in the direction of the propeller and parallel to the gearbox/housing contact surfaces. Hold it in fixed position not allowing any rotation. Pliers or an open-end spanner can be used.
3	Insert feeler gauge of check gauge CS-PTO into the guide pin. NOTE: The feeler gauge is symmetrical, both sides can be used.
4	Insert feeler gauge until a first resistance can be felt. Now the feeler gauge faces the cylindrical crankshaft journal (see Fig. 3, Step. 1).
5	With slightly elevated force you can push the feeler gauge about 2 mm (.078 in.) further in, until it touches the plan surface of the pinion gear (see Fig. 3, Step. 2). NOTE: The mark on the feeler gauge is still visible outside the slot.

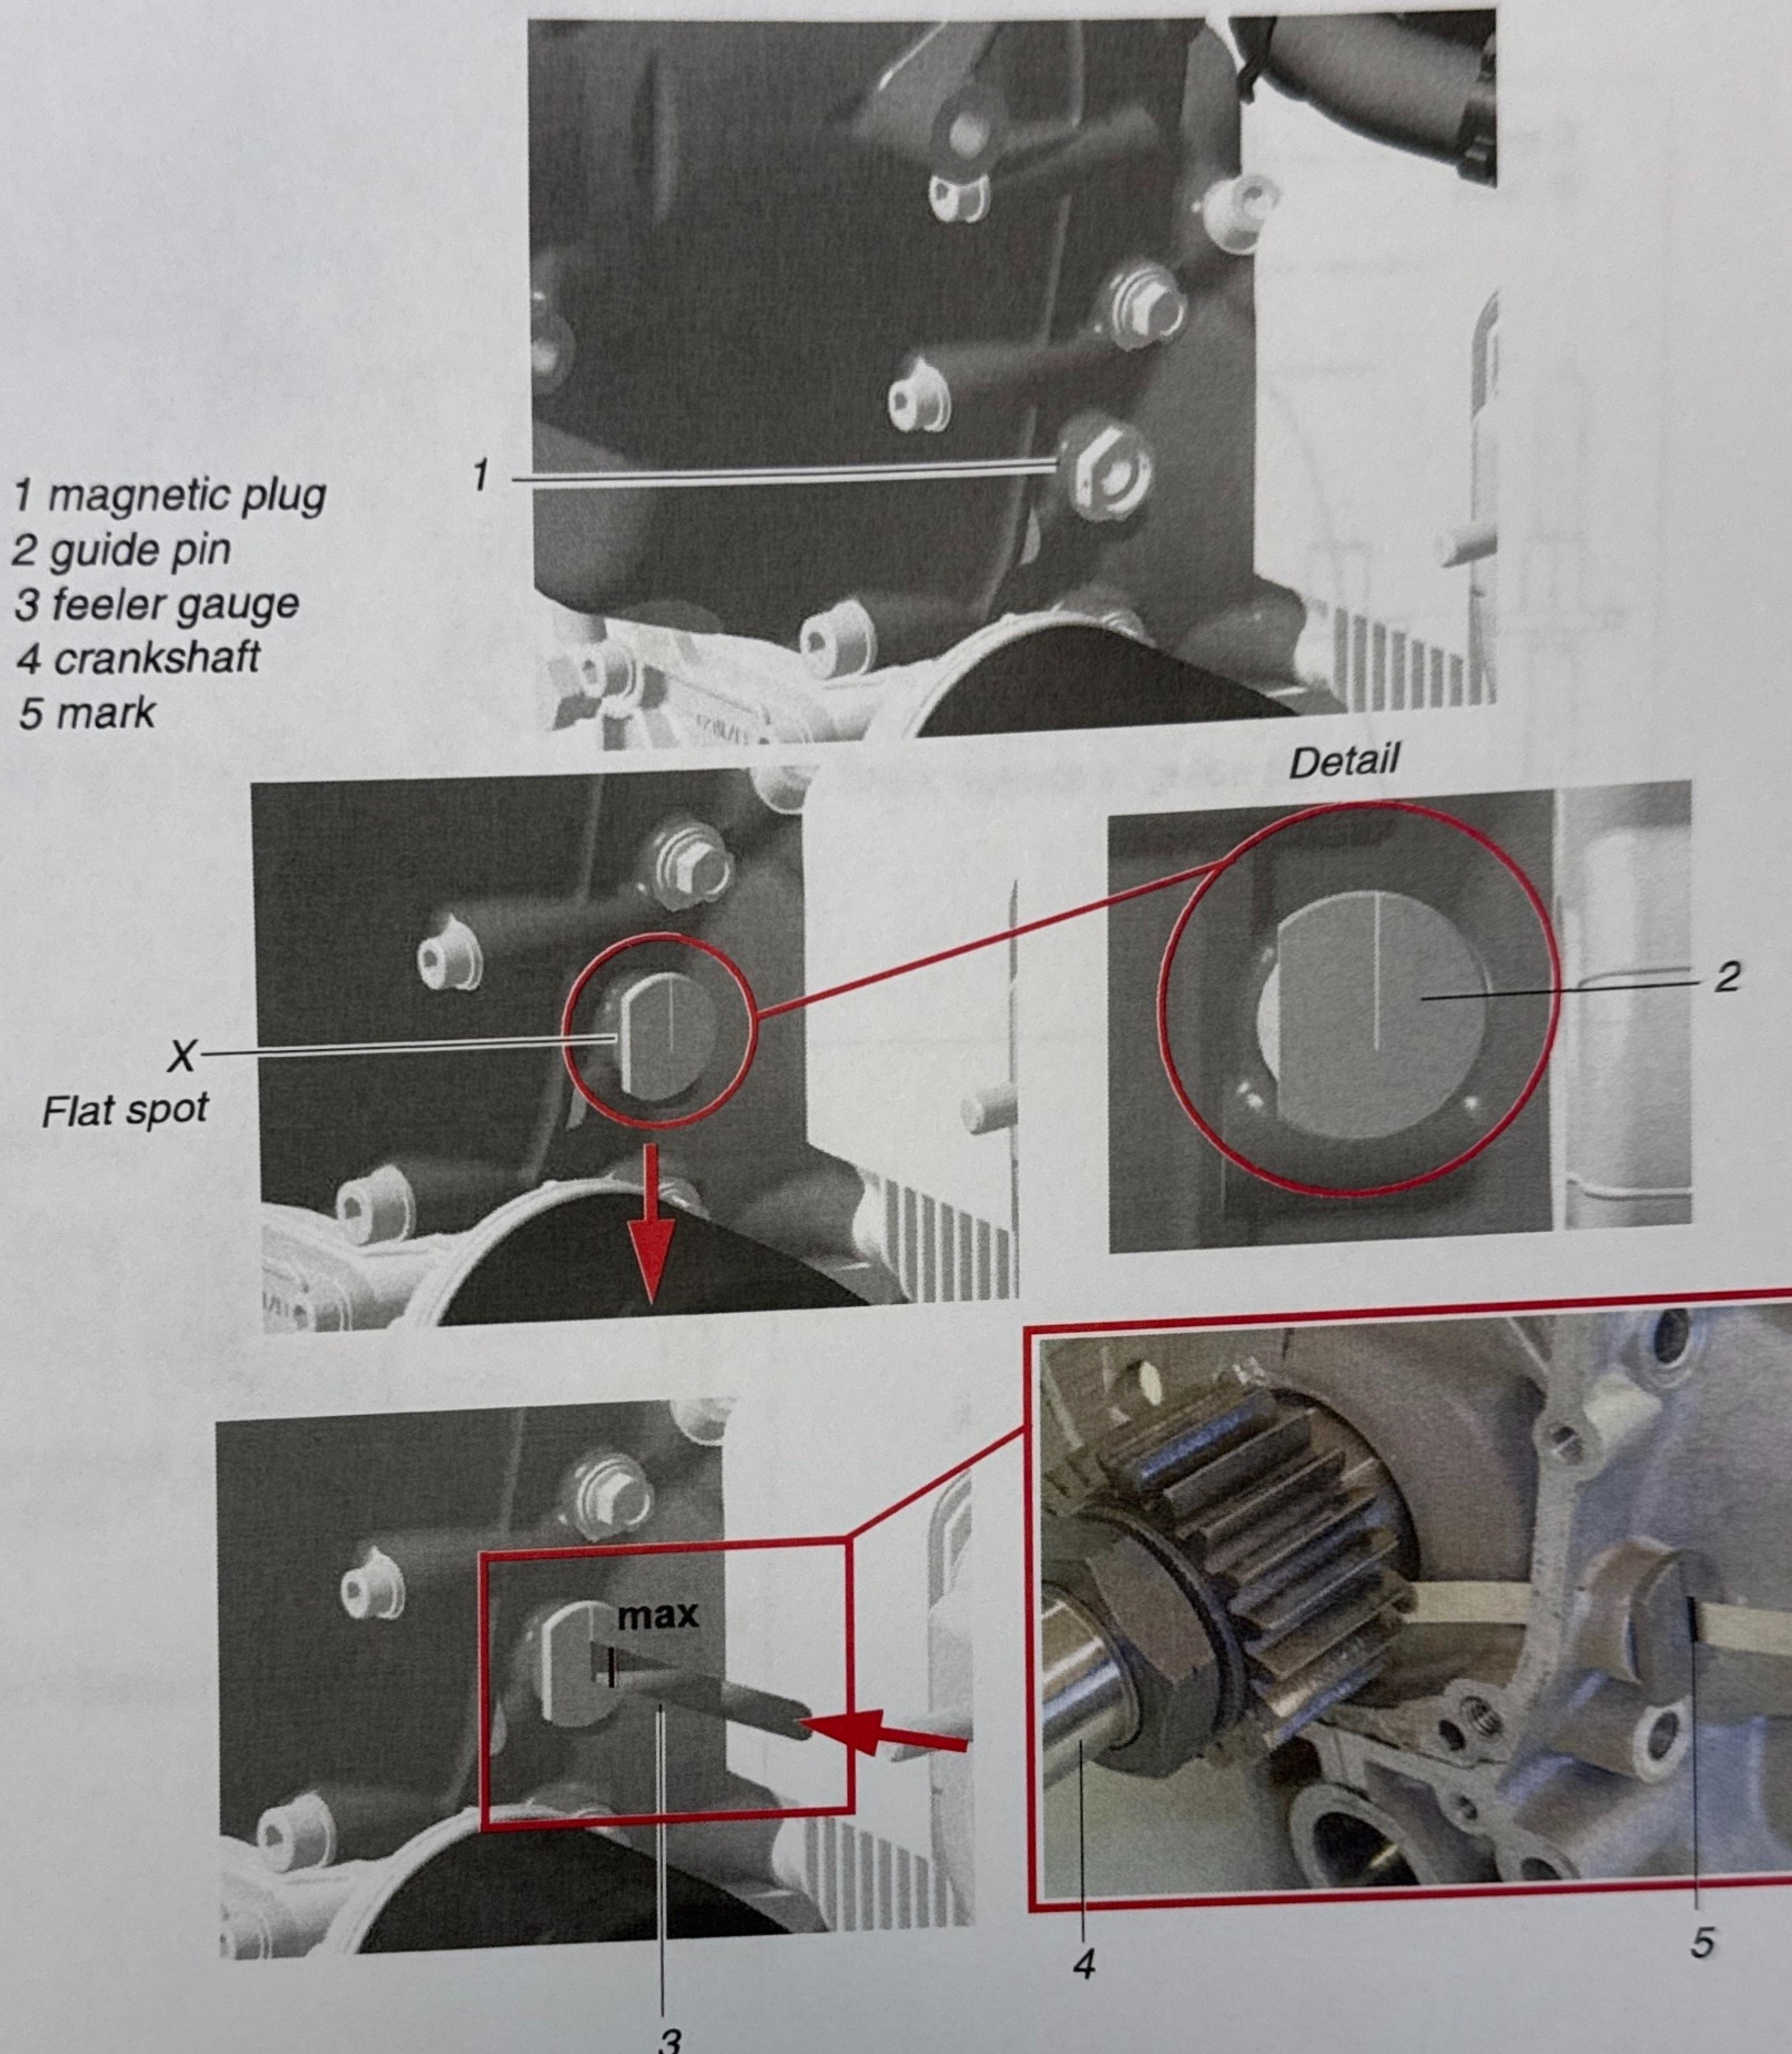
### Fig. 2 Inspection with feeler gauge

Step	Procedure
6	Push the check gauge into the guide pin with increased force and make sure that the guide pin has not turned. If the drive gear is in correct position and cannot be moved the crankshaft is OK. The feeler gauge cannot be further moved in and the mark (5) remains visible outside the slotted screw.
<b>Result = Crankshaft journal OK</b>	
7	Remove the check gauge CS-PTO (feeler gauge and guide pin).
8	Install the magnetic plug in accordance with the relevant Maintenance Manual (Line).

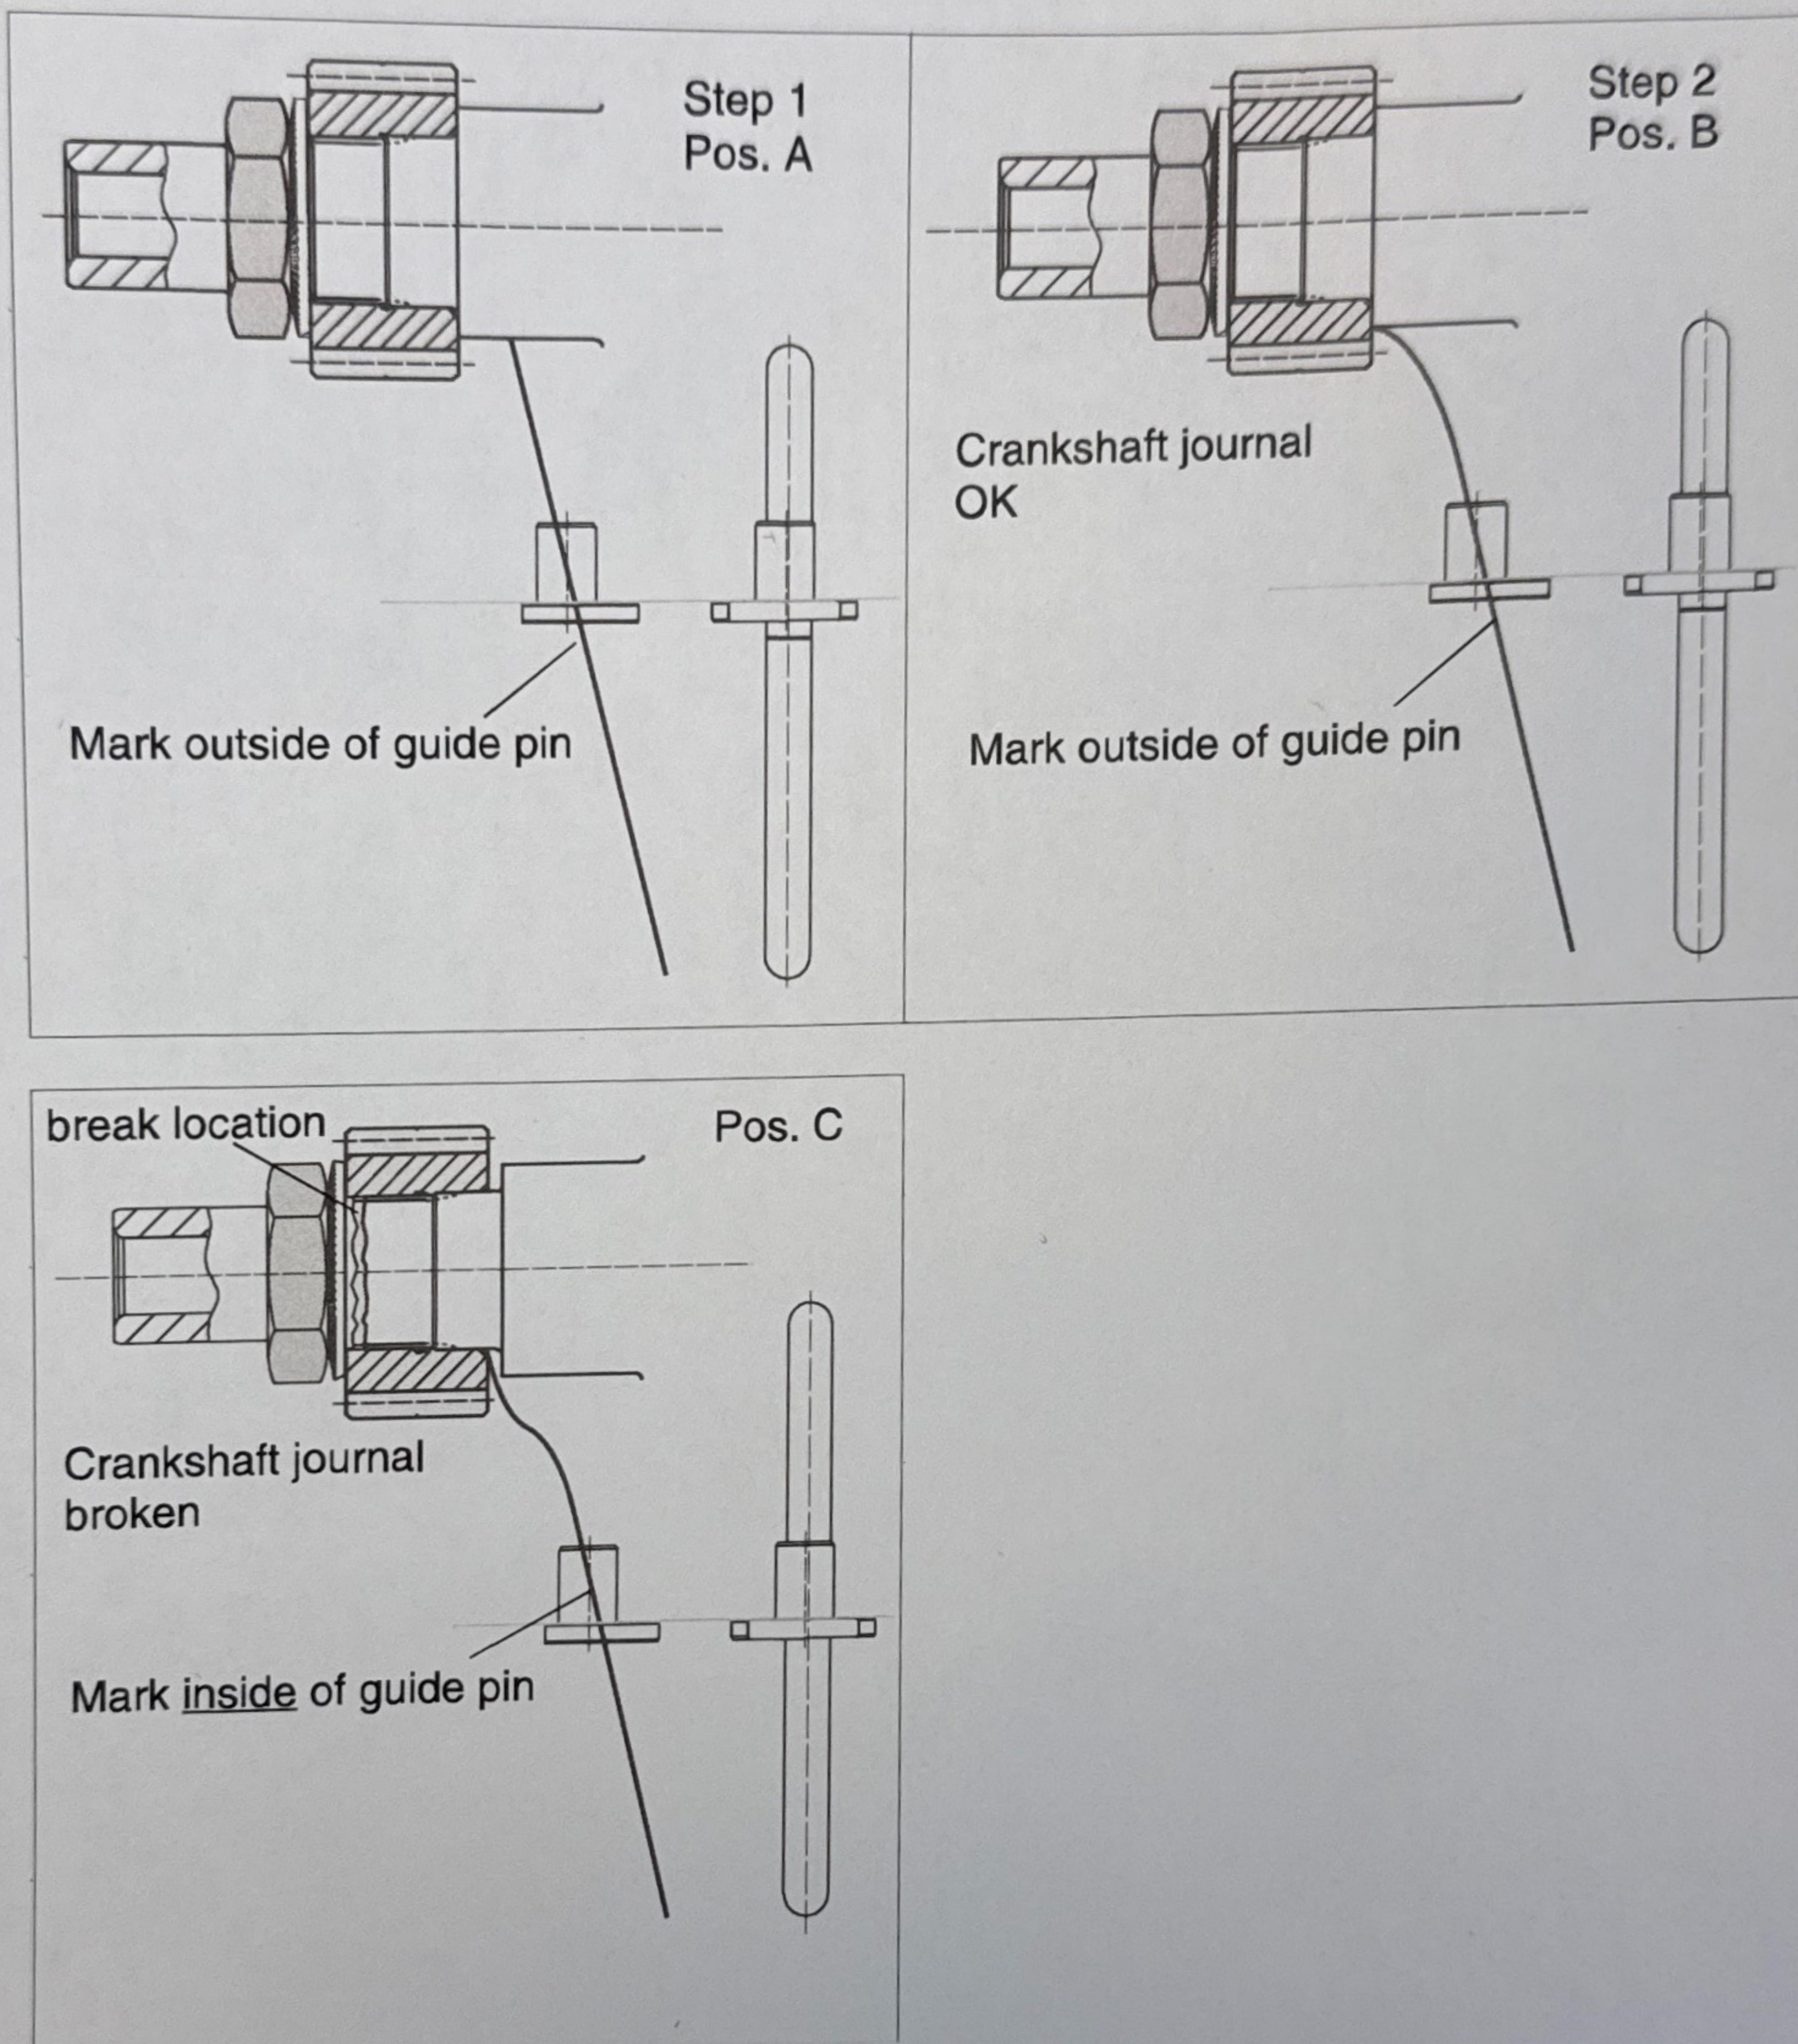
Fig. 3

Step	Procedure
6	Hold it in fixed position not allowing any rotation. If the feeler gauge can be pushed further in, so that the mark disappears in the slot, then the gearbox must be removed and the crankshaft must be checked (see Fig. 3, Pos. C).
<b>Result = Crankshaft journal broken</b>	
7	Please find further explanations if needed in this chapter 3.2).

The replacement of the crankshaft is only necessary, if inspection result 2 is applicable.

- In case of a broken crankshaft journal or any doubt contact your aircraft manufacturer and your nearest authorized ROTAX® aircraft engine distributor.
