MAJOR REPAIR AND ALTERATION
(Airframe, Powerplant, Propeller, or Appliance)

1. Aircraft	Nationality and Registration Mark N414JT	Serial No. 414-0840
	Make Cessna 414	Model 414

This section provides Instructions for Continued Airworthiness for the GTX 33X and GTX 3X5 with ADS-B installation. This section satisfies the requirements for continued airworthiness as defined by 14 CFR Part 23.1529 and Part 23 appendix G. Information in this section is required to maintain the continued airworthiness of the GTX 33X and GTX 3X5 as installed under this AML STC.

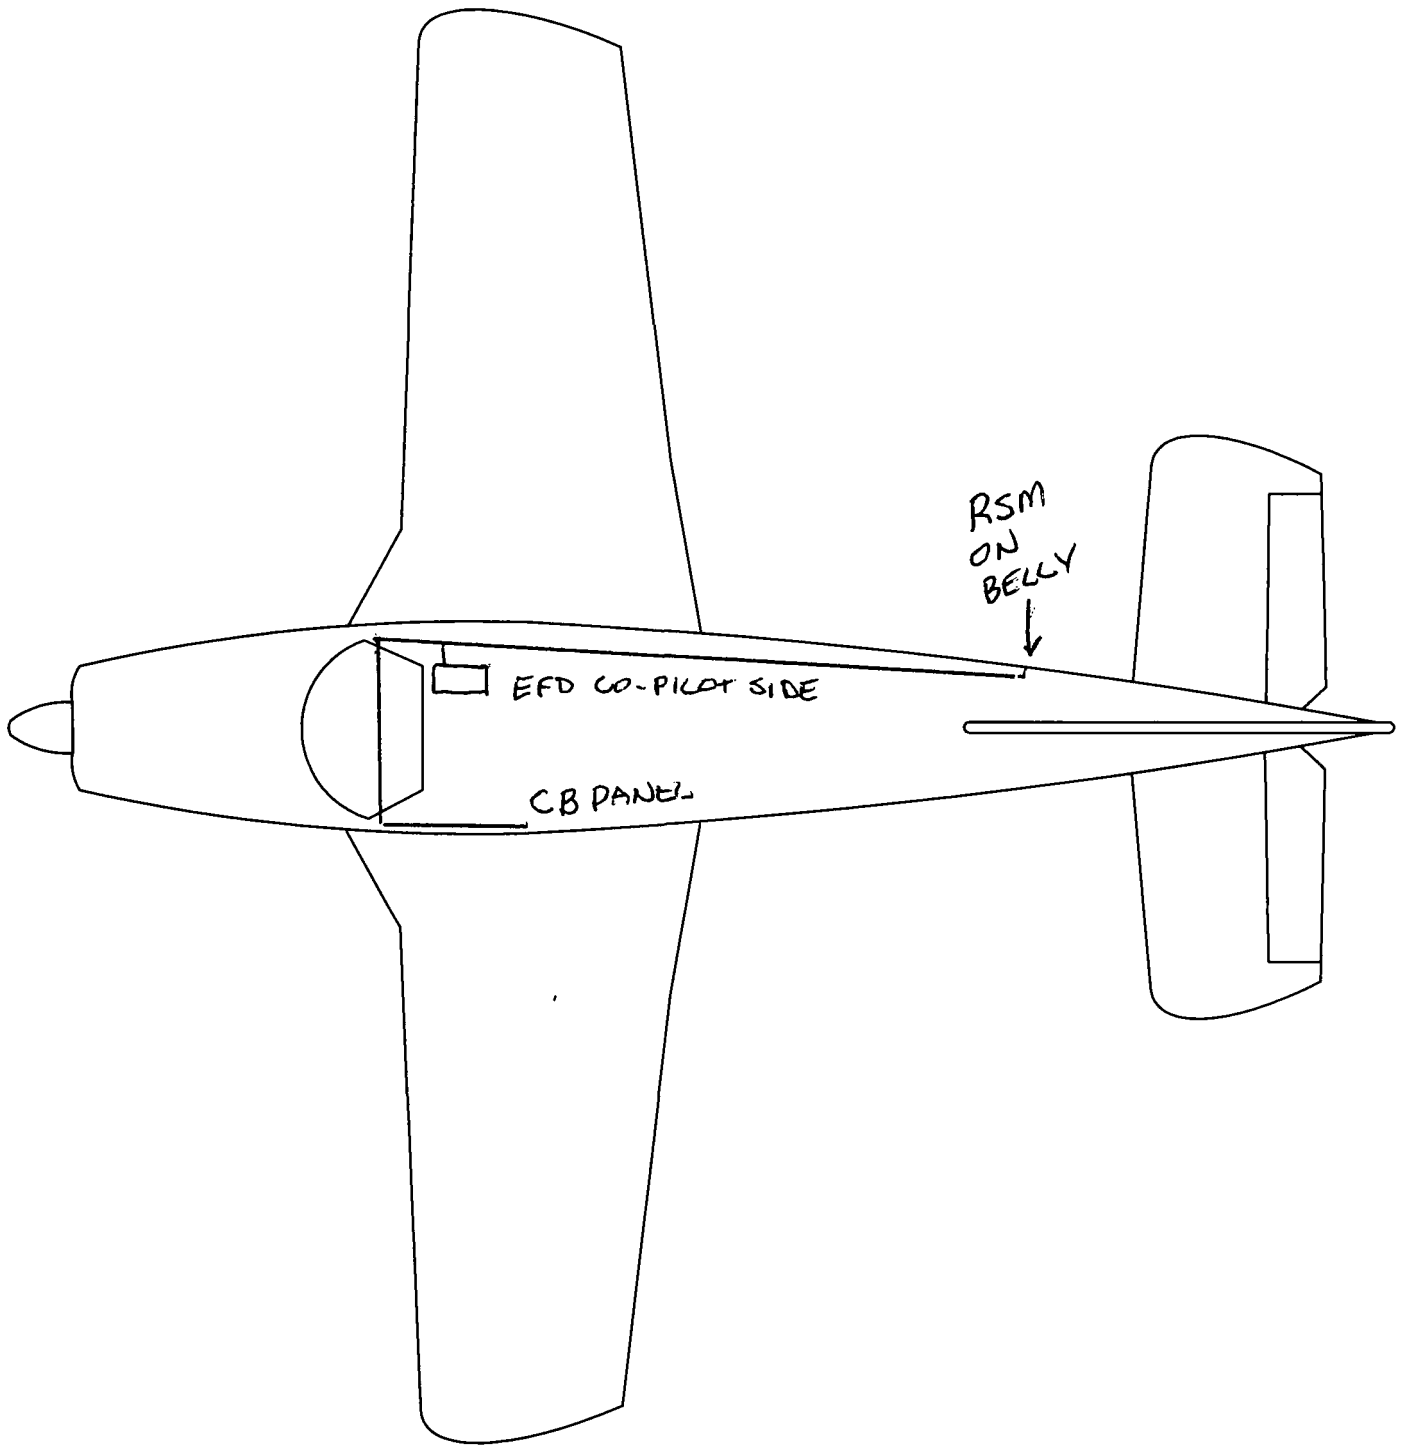
Figure 1 - EFD1000 Components and cable routing (top view)

- a) Draw in the locations of the EFD1000 system, including the EFD(s) (PFD, EBD, E5, MFD), RSM, optional ACU/ACU2, EBB58, EA100, CG100 and autopilot locations (Figures 1 and 2).
- b) Draw in the circuit breaker and switch locations on instrument panel (Figure 3).
- c) Draw in the EFD to RSM cable routing, including wire type and wire size.
- d) Draw in the ACU to EFD and ACU to autopilot cable routing, including wire type and wire size.
- e) Draw in the optional EA100 to EFD and EA100 to autopilot cable routing, including wire type and wire size.
- f) Draw in the optional CG100 to MFD cable routing.
- g) Draw in the optional CG100 USB port locations.
- h) Show the location of access panels for inspection and servicing the EFD1000 system, including diagrams of the access plates and any information necessary to gain access when access plates are not provided.

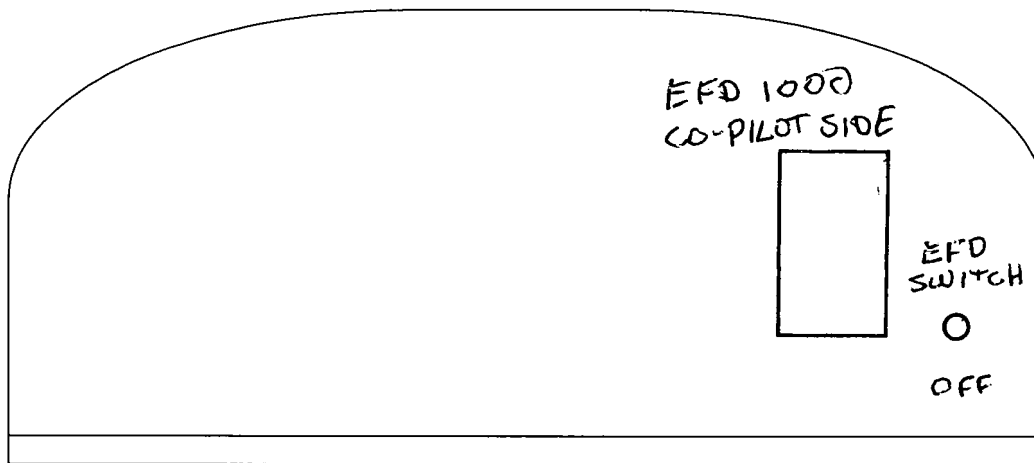
Figure 3 - Circuit Breaker and Switch Locations

- a) PFD/MFD/EBD/E5 circuit breakers
- b) PFD/MFD/EBD/E5 switch(s)
- c) ACU circuit breaker(s) - optional
- d) A/P AHRS circuit breaker -w/opt. EA100
- e) EBB58 Emergency Disconnect Switch
- f) A/P AHRS FAIL light - w/ opt. EA100
- g) PRESEL/(ARMED) switch - optional
- h) A/P Source switch - optional
- i) GTWY circuit breaker - optional
- j) ASPEN GTWY switch - optional

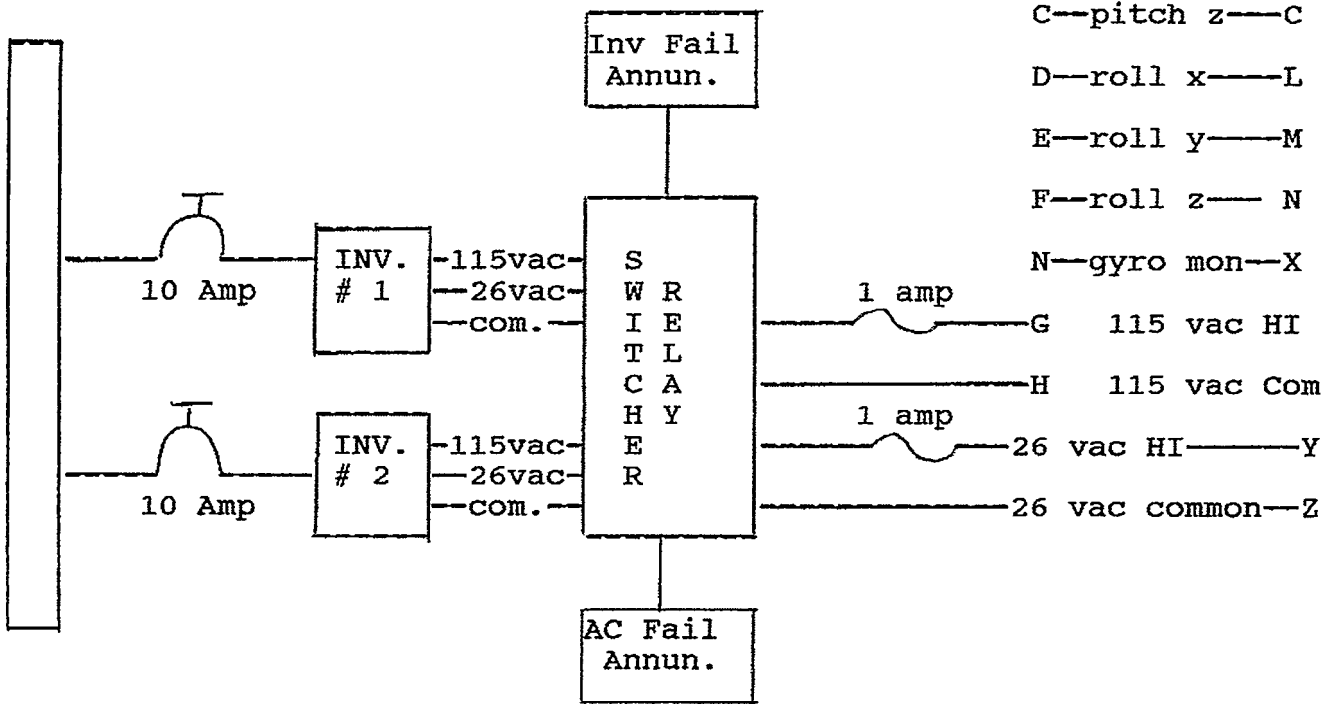
Power connections and gyro interface for FD-108 Indicator

AVIONICS CIRCUIT INVERTER INVERTER FUSES VERT FD-108
 BUSS BREAKER BREAKER SWITCHING GYRO INDICATOR

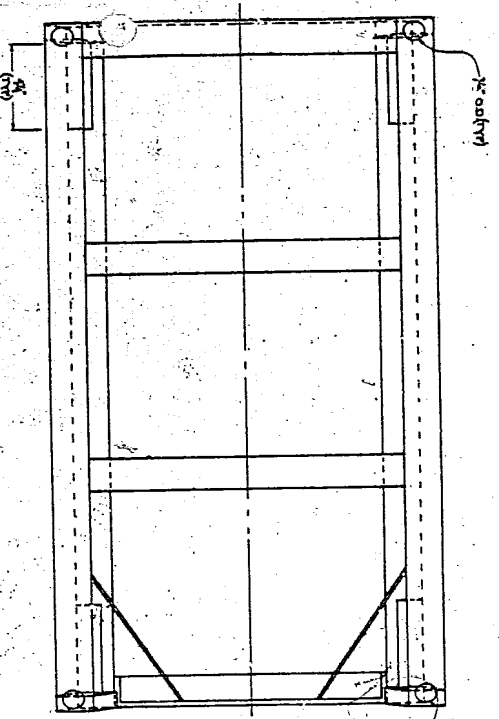
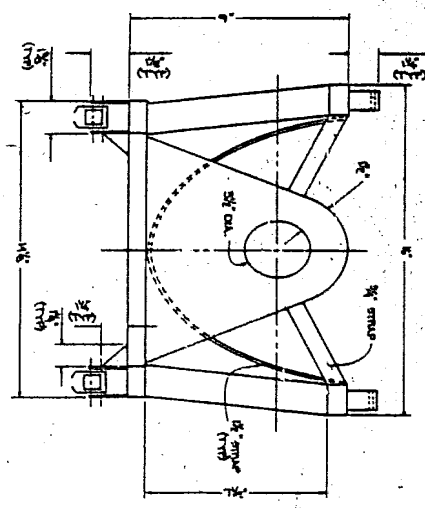
AIR AMBULANCE INC.
 AIRCRAFT STRETCHER ADAPTER/MOUNT
BILL OF MATERIALS:
 ALL SQUARE/RECTANGULAR TUBING 4130 STEEL
 ALL FLAT STOCK AND STRAPS 106 4130 STEEL
 ALL ROUND TUBING .083 WALL 4130 STEEL
 ROLLER/SUPPORT ASSEMBLIES CESSNA
 AIRCRAFT CO. PARTS: ROLLER C4244-1
 SUPPORT 511207-1
